Shadow Run Dam Corporation, Inc.
Shadow Run Dam, 2025 Visual Inspection

Performed on December 13, 2025

Subject: Shadow Run Dam 2025 Biennial Inspection Riverview, Florida

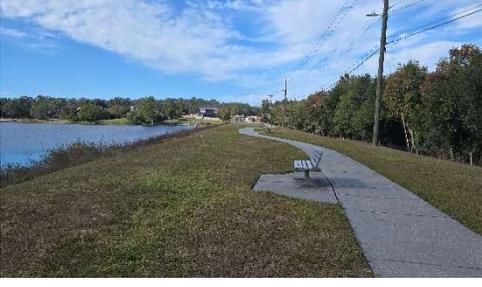
Photo 1

- The crest has been recently mowed. The crest has good grass coverage and is free of large vegetation. The paved path is in good condition. No cracking was observed within the pavement nor on the embankment surface (Photo No. 1 and 2).

<p>View of dam crest facing left from the left abutment. Good grass coverage and recently mowed. A walking path extends the length of the embankment. Note, utility lines along the downstream shoulder.</p>

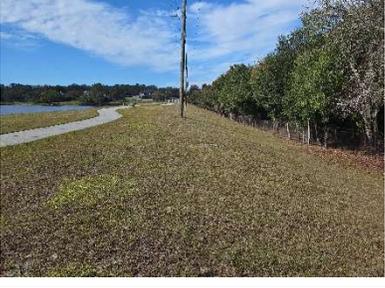
Photo 2

<p>View of embankment crest, facing left from the right abutment. Good grass coverage and recently mowed. A walking path extends the length of the embankment. Note, utility lines along the downstream shoulder.</p>

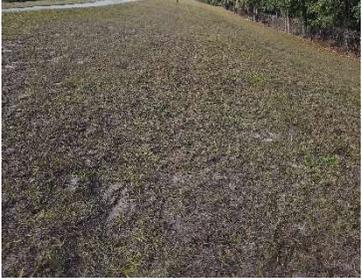
Photo 3

- After straightening, the power poles appear to be in good alignment (Photo No. 3). However, these are expected to continue tilting downslope as the downstream slope slides downward due to surface water infiltration. The powerline connecting to the lift gate control should be observed to make sure that it is not overstressed by the expected future downslope tilting.

<p>View of utility poles, facing left from the right abutment. Note, 3rd pole is leaning downstream at an angle of approximately 4 degrees from the vertical.</p>

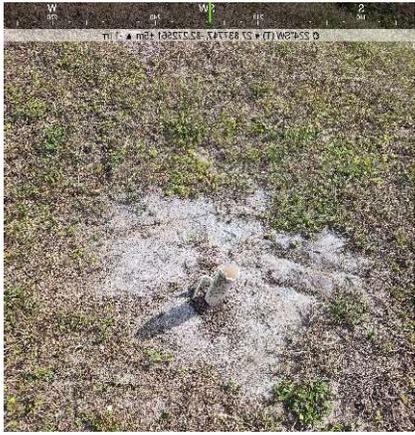
Photo 4

- An abandoned piezometer (MW-1) is located near the right abutment. The piezometer pipe is broken above the ground surface and is missing a cap (Photo No. 4). A second piezometer (MW-2) was noted on the plans and previous visual safety inspection. However, this was not identified during the 2023 nor 2025 safety inspection.

A piezometer (MW-1) is located along the eastern side of the dam crest. The piezometer PVC protective casing and well casing were broken, and no cap was present on the well. Therefore, no readings were taken. A piezometer (MW-2) is shown on the design plan located approximately 350 ft east of the spillway. This has been observed in previous inspections. However, it was not observed during the 2025 inspection.

December 13, 2025 10:53 AM	
View of abandoned piezometer MW-1. Note, the piezometer pipe is broken above the ground surface and is missing a cap.

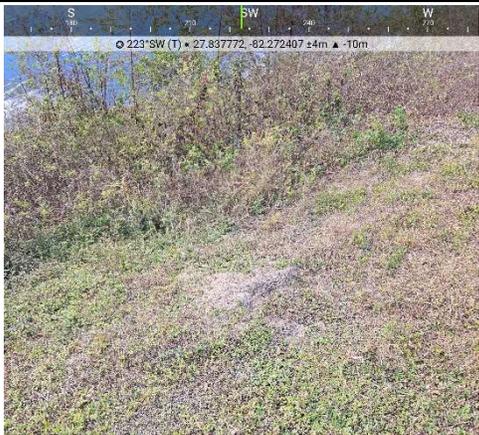
Photo 5

December 13, 2025 10:51 AM	
View of ant mound on upstream slope, right of the spillway.

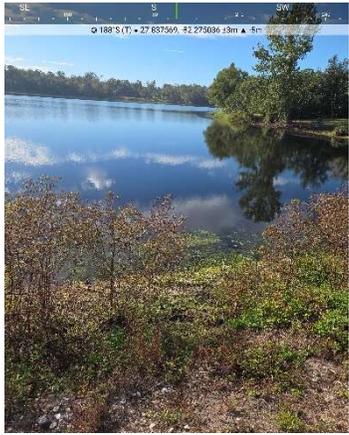
Photo 6

December 13, 2025 9:19 AM	
View of reservoir shoreline on the left side of the dam. Note, overgrown woody vegetation along the shoreline. Note, organic material in reservoir. Note, shoreline protection is absent, and signs of erosion are visible.

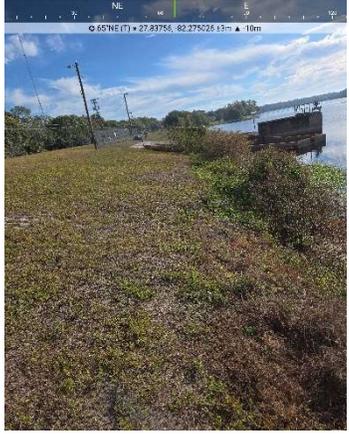
Photo 7

December 13, 2025 9:19 AM	
View of depression near shoreline left of the spillway intake. Note, overgrown woody vegetation along the shoreline.

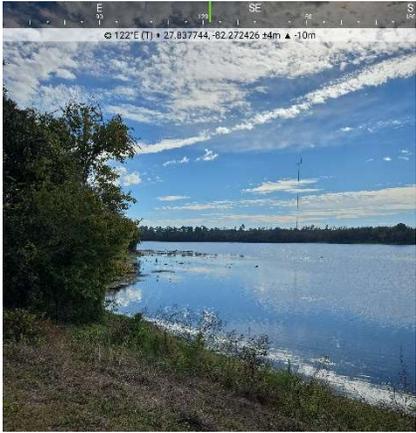
Photo 8

- Slope oversteepening (erosion) has progressed along the shoreline, with a substantial increase in erosion compared to previous inspections. This is due to wave action against the slope. Conditions are notably worse, particularly on the right side of the dam between the spillway and right abutment, where scarps now exhibit more extensive near-vertical faces and deeper cuts (Photo No. 8).

December 13, 2025 10:51 AM	
View of near vertical scarps on the right side of the dam, facing the right abutment. Note, poor grass coverage and overgrown woody vegetation.

- These over-steepened portions of the upstream slope represent tripping and fall hazards and should be isolated from foot traffic to prevent injuries.

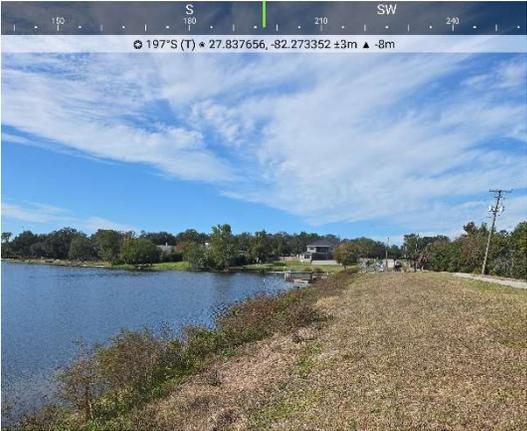
Photo 9

December 13, 2025 11:07 AM	
View of over steepened upstream slope facing left abutment. Note, poor grass coverage and overgrown woody vegetation.

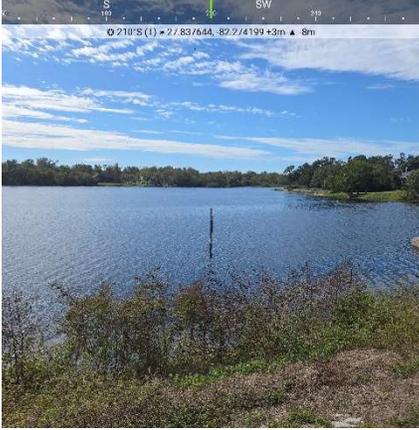
Photo 10

December 13, 2025 11:11 AM	
View of lake level gauge from embankment crest.

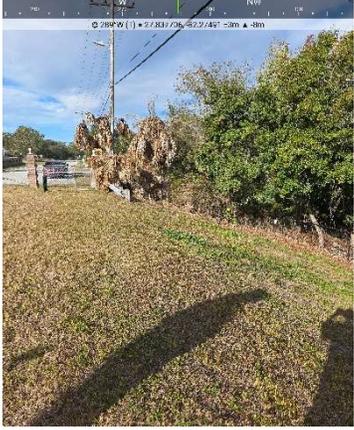
Photo 11

December 13, 2025 9:21 AM	
View of downstream slope along the left abutment. Note, poor grass coverage.

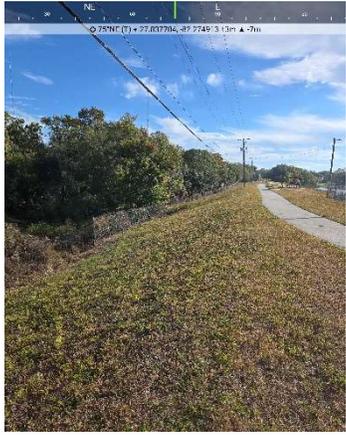
Photo 12

December 13, 2025 9:21 AM	
View of downstream slope, facing right from left abutment. Note, uneven slope surface.

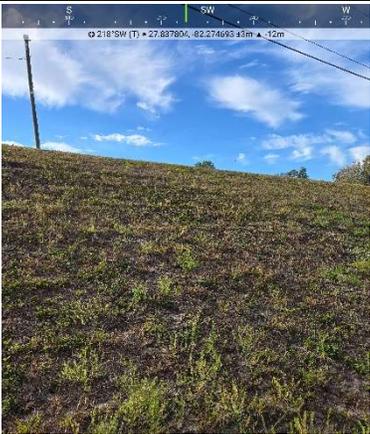
Photo 13

December 13, 2025 9:23 AM	
View of downstream slope, facing upstream. Note, uneven slope surface.

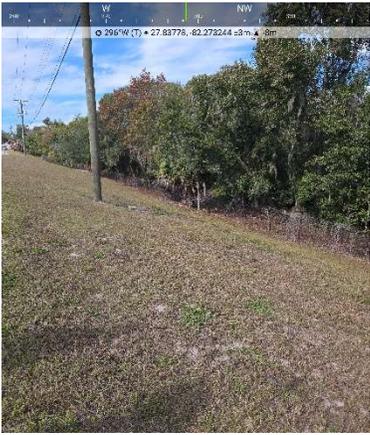
Photo 14

December 13, 2025 11:06 AM	
View of downstream slope facing left from right abutment. Note, uneven slope surface.

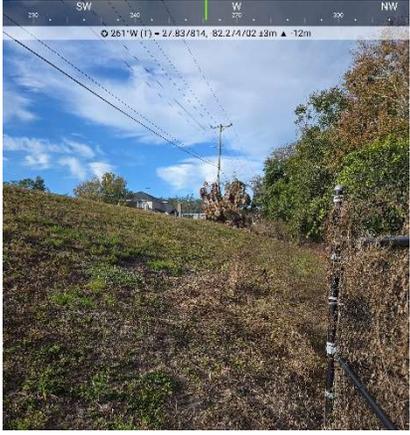
Photo 15

December 13, 2025 9:23 AM	
View of shallow ruts on downstream slope located left of the spillway.

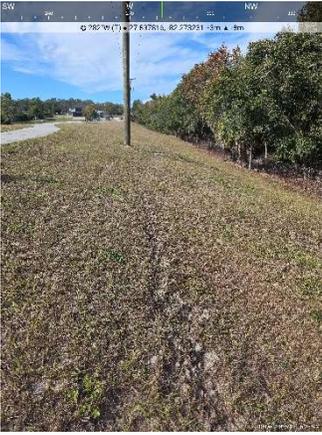
Photo 16

December 13, 2025 11:06 AM	
View of shallow ruts on downstream slope.

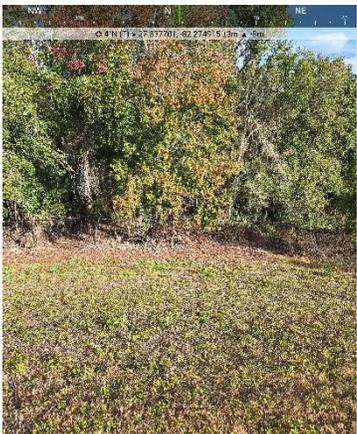
Photo 17

parallel to the embankment. This low point was not previously identified in the 2023 inspection (Photo No. 17).

December 13, 2025 9:21 AM	
View of low area on downstream slope. Note the slope subsidence is in line with low point in the downstream toe area along the unnamed tributary running parallel to the embankment.

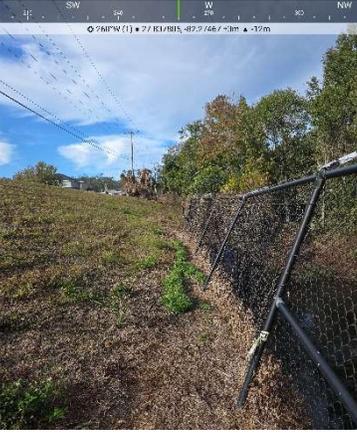
Photo 18

December 13, 2025 9:24 AM	
View of security fence facing the left abutment from the right side of the spillway. Note the security fence is leaning downstream.

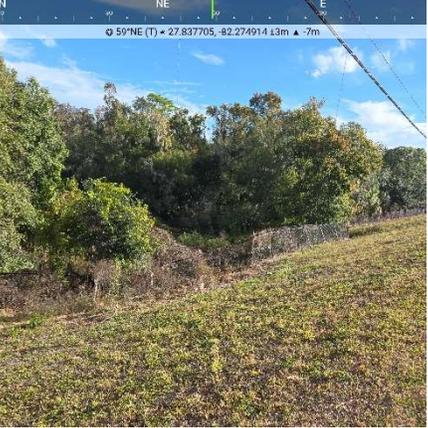
Photo 19

December 13, 2025 9:21 AM	
View of oversteepening/erosion of the downstream slope along left side of security fence. Note, overgrown grassy and woody vegetation on the fence line.

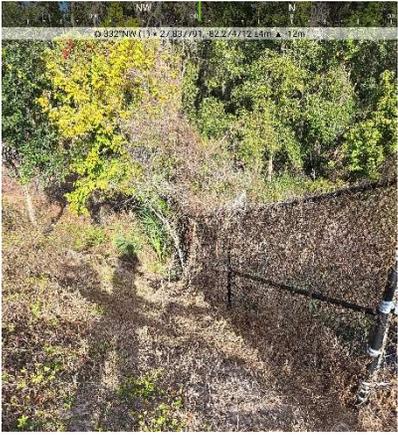
Photo 20

December 13, 2025 9:22 AM	
View of oversteepening/erosion along left side of the security fence. Note, owner says pathway used by community residents to fish in the exit channel.

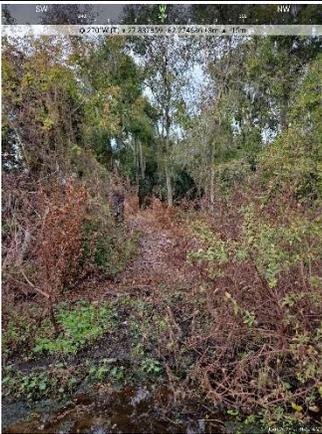
Photo 21

December 13, 2025 9:30 AM	
View of overgrown grassy and woody vegetation downstream of embankment toe. Note, a footpath is visible.

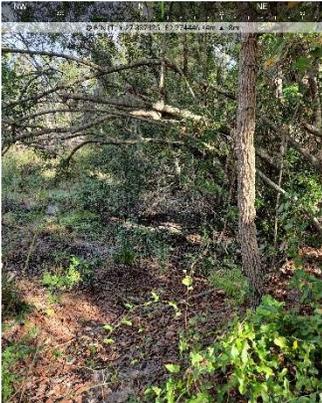
Photo 22

December 13, 2025 10:15 AM	
View of small wet area downstream of embankment toe.

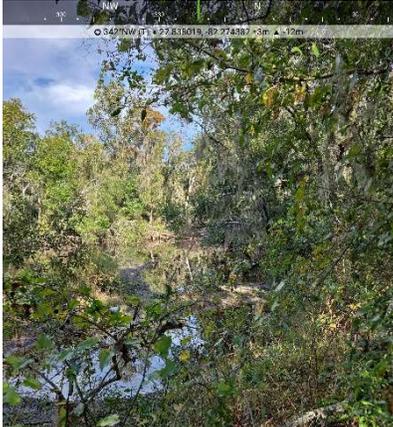
Photo 23

December 13, 2025 10:15 AM	
View of standing water downstream of embankment toe.

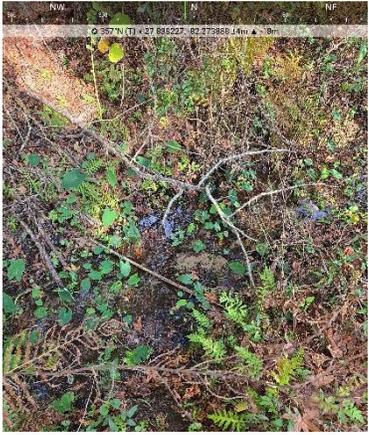
Photo 24

December 13, 2025 10:24 AM	
View of wet soil near unnamed tributary of Bell Creek. Recommend to remove vegetation to observe more easily.

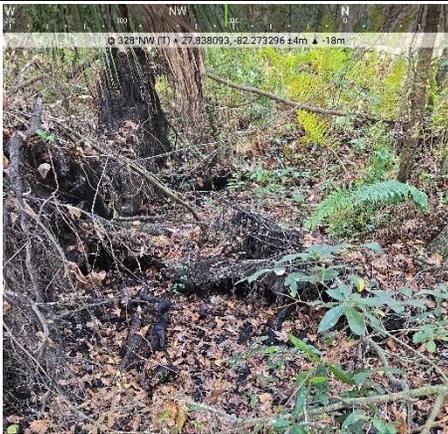
Photo 25

December 13, 2025 10:34 AM	
View of uprooted tree adjacent to unnamed tributary of Bell Creek.

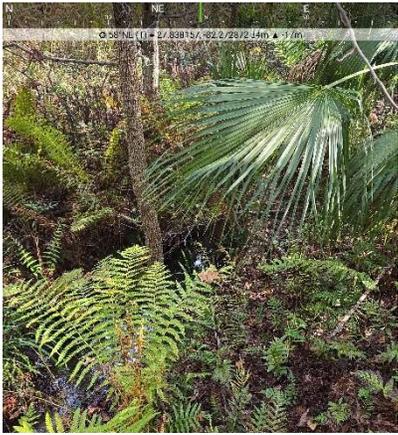
Photo 26

December 13, 2025 10:39 AM	
View of lowest point along unnamed tributary of Bell Creek. Recommend to clear area and conduct a quarterly visual inspection.

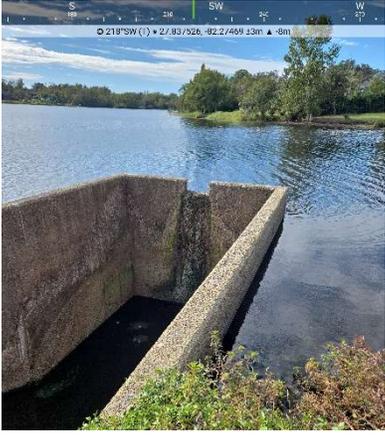
Photo 27

December 13, 2025 11:17 AM	
View of left drop inlet spillway with notched weir. Note a floating barrier is not present around reservoir-side of the spillway perimeter.

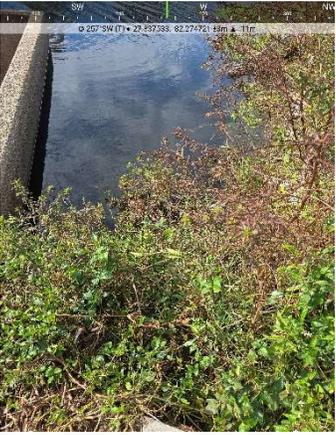
Photo 28

December 13, 2025 11:16 AM	
View of woody and grassy vegetation along the left spillway wingwall.

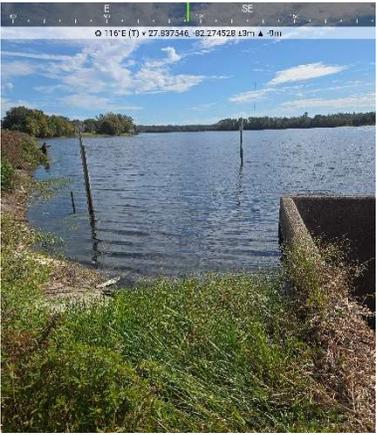
Photo 30

December 13, 2025 11:15 AM	
View of woody and grassy vegetation along right spillway wingwall.

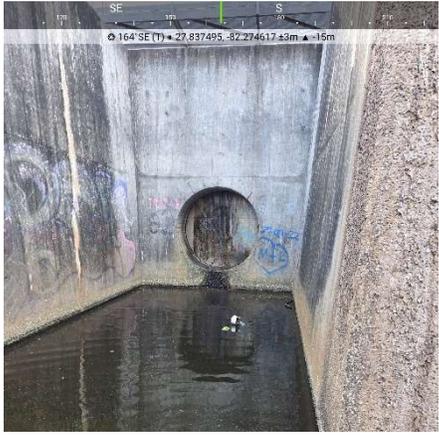
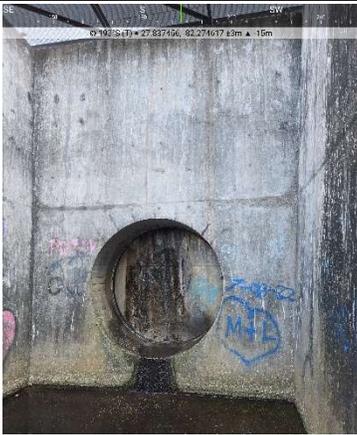
- Aquatic vegetation is present within the stilling basin (Photo No. 43).
- A buildup of material was noted along the top of the gate seal. Leakage was observed along the seating joint of a circular discharge gate. This indicates a wear on the seal. Based on images from previous inspections, the leakage around the gate does not appear to be worsening (Photo No. 32 and 33).

December 13, 2025 9:33 AM	
View of leakage along the seating joint circular discharge gate.

December 13, 2025 9:34 AM	
View of leakage along the seating joint circular discharge gate.

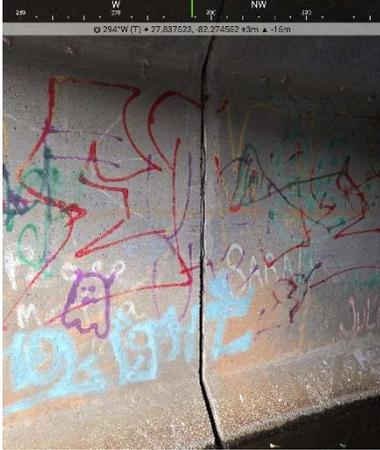
Photo 34

December 13, 2025 9:35 AM	
View of apparent gapping within concrete conduit joint. Note gapping at the bottom of conduit is wider than at the top.

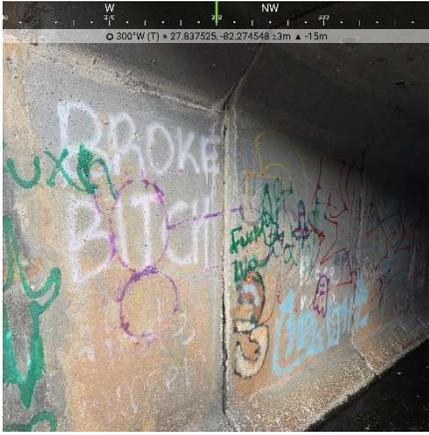
<p>Photo 35</p>

<p>December 13, 2025 9:46 AM</p>	
<p>View of efflorescence at the ceiling and wall joints.</p>	
<p>Photo 36</p>

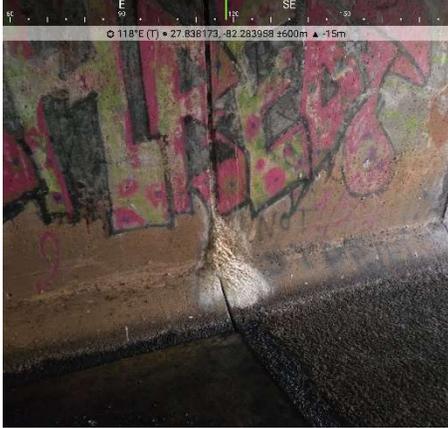
<p>December 13, 2025 9:32 AM</p>	
<p>View of efflorescence between the culvert sections.</p>	
<p>Photo 38</p>

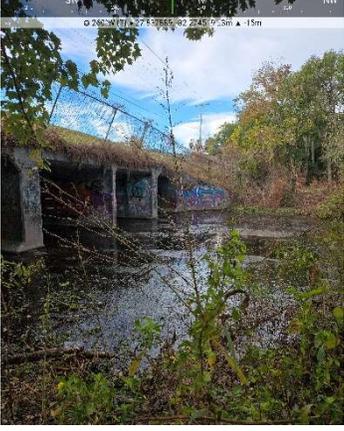
<p>December 13, 2025 9:26 AM</p>	
<p>View of vegetation surrounding spillway exit channel.</p>	
<p>Photo 39</p>

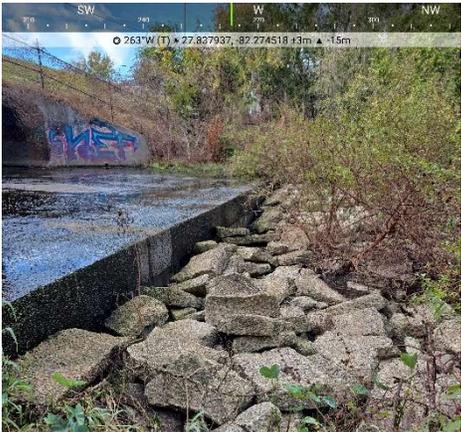
<p>Photo 40</p>

<p>December 13, 2025 9:28 AM</p>	
<p>View of splash pad with large broken concrete pieces along the toe near the culvert outlet. Note, the concrete pieces appear displaced and settled, with visible material loss and signs of erosion.</p>	
<p>Photo 41</p>

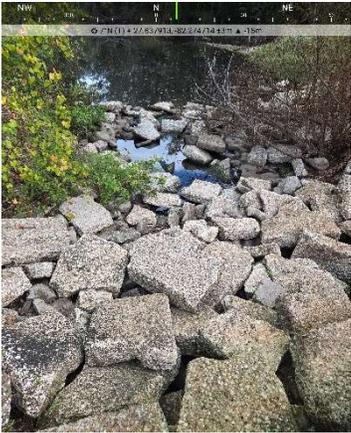
<p>December 13, 2025 9:21 AM</p>	
<p>View of riprap and broken concrete pieces along the channel outlet area. Note, several pieces appear displaced and settled, with voids between blocks and signs of erosion around the toe.</p>	
<p>Photo 42</p>

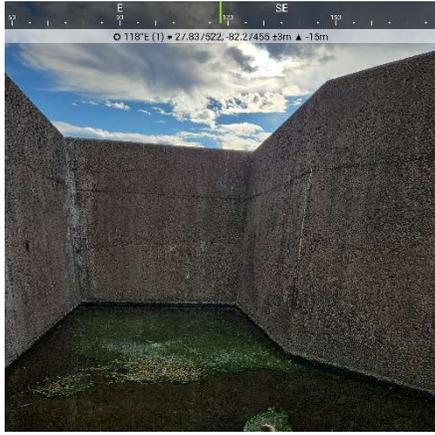
<p>Photo 43</p>

<p>December 13, 2025 9:35 AM</p>	
<p>View of right drop inlet spillway from stilling basin. Note, organic material in stilling basin.</p>	
<p>Photo 44</p>

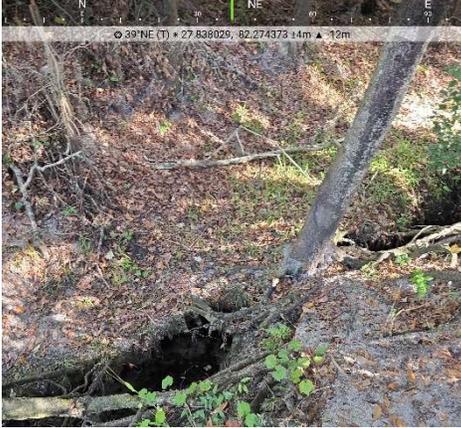
<p>December 13, 2025 10:16 AM</p>	
<p>View of eroded area exposing tree roots and creating a void near the base of a tree. Note, soil loss and potential instability along the slope.</p>	
<p>Photo 45</p>

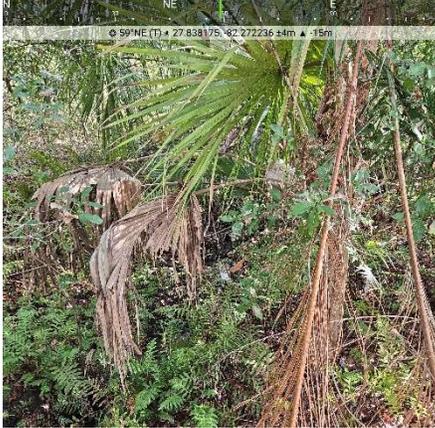
<p>December 13, 2025 10:43 AM</p>	
<p>View of overgrown grassy and woody vegetation along unnamed tributary of Bell Creek.</p>
