Shadow Run Dam Corporation, Inc.
Shadow Run Dam, 2025 Visual Inspection

Performed on December 13, 2025

Subject: Shadow Run Dam 2025 Biennial Inspection Riverview, Florida

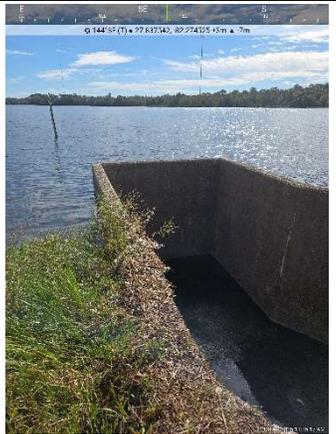
Photo 29

- A floating barrier was not present around the reservoir-side perimeter of the spillway (Photo No. 27).
- Woody and grassy vegetation were present along the left and right spillway wingwalls. Loose material was identified near the concrete wingwalls and concrete slab (Photo No. 27 through 30).
- The lake level was lowered prior to the inspection. Minimal flow was observed in the spillway, and the notched weir was not discharging during the inspection. (Photo No. 31).
- Moisture was observed to be coming through the concrete spillway walls to right of the

December 13, 2025 11:15 AM	
View of right drop inlet spillway.

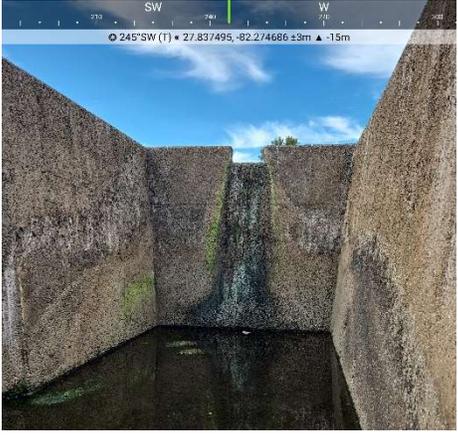
Photo 31

December 13, 2025 9:33 AM	
View of left drop inlet spillway with notched weir from stilling basin.

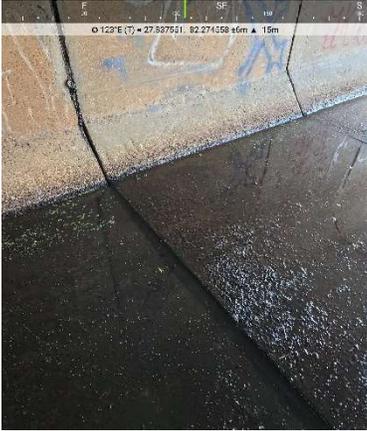
<p>December 13, 2025 9:36 AM</p>	
<p>View of joint along the bottom of the conduit.</p>	
<p>Photo 37</p>

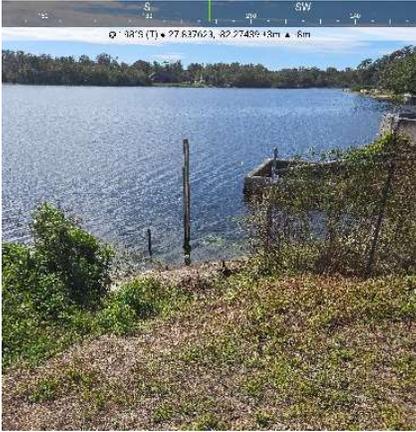
<p>Photo 40</p>

- The spillway exit channel into Bell Creek is protected with riprap, downstream of the outlet apron exit slab. Visual inspection of the exit slab revealed large broken concrete pieces along the toe that serve as the riprap. Some of these pieces appear displaced and settled compared to their position during the last inspection, with visible voids between the blocks and indications of erosion. These results may indicate material loss and continued erosive forces. No obstructions were identified within the exit channel. The exit channel shoreline is overgrown with grassy vegetation and small to large trees (Photo 40 and 41).

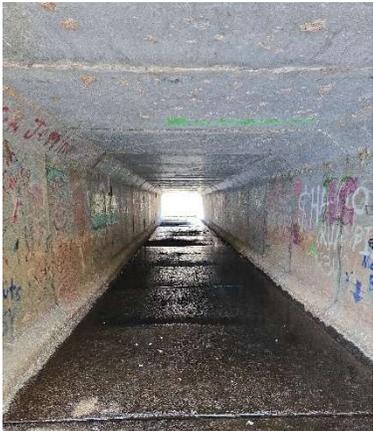
<p>Photo 43</p>

<p>December 13, 2025 9:31AM</p>	
<p>View inside concrete box culvert showing interior walls and ceiling.</p>
